TECHNICAL NOTE 3269

ADDITIONAL STATIC AND FATIGUE TESTS OF HIGH-STRENGTH  
ALUMINUM-ALLOY BOLTED JOINTS

By E. C. Hartmann, Marshall Holt, and I. D. Eaton

Aluminum Company of America

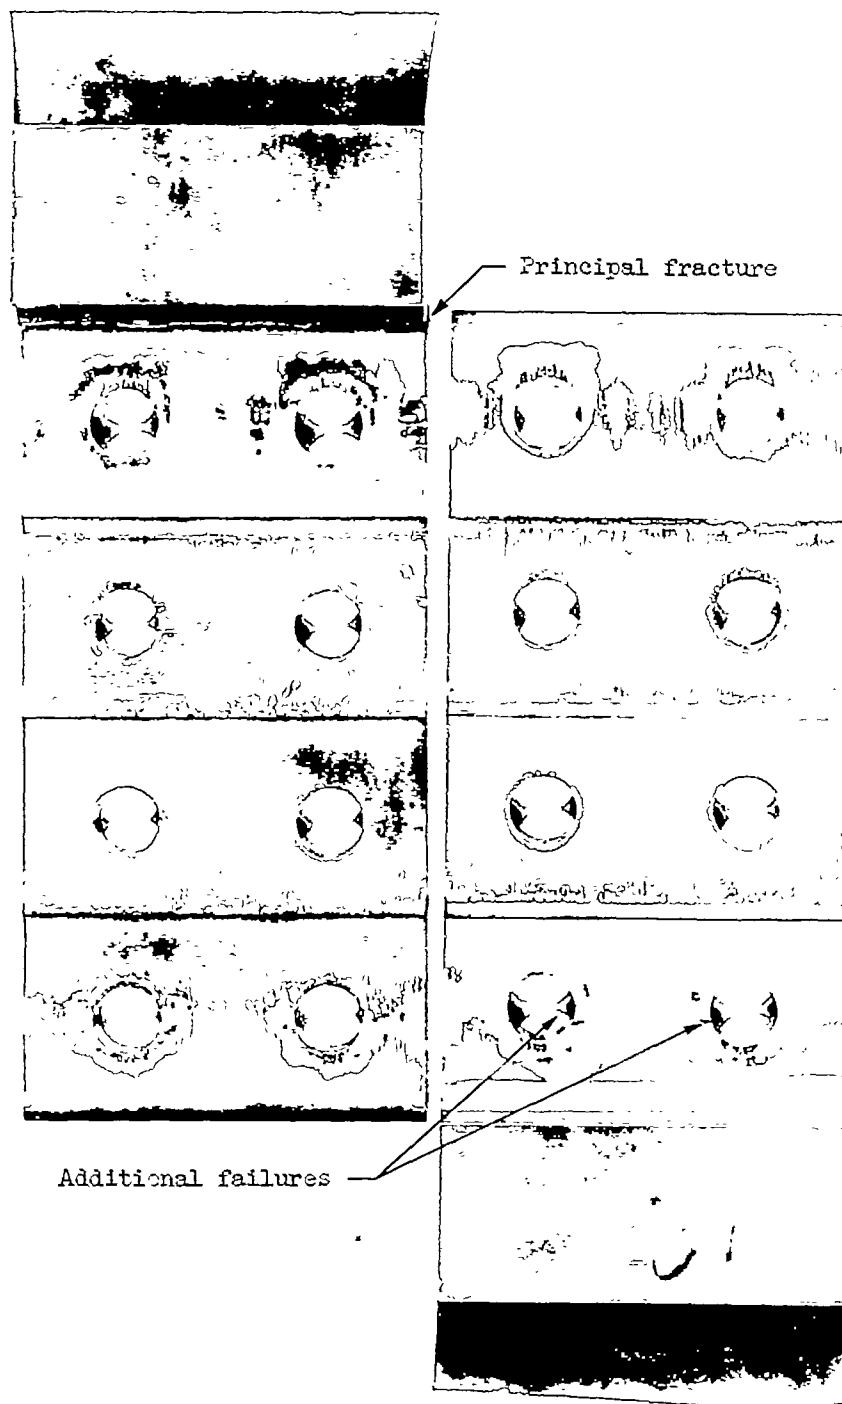
Figure 17.- Failures in 24S-T4 nonuniform-step joint. L-83697

When the bolts were removed individually from the reassembled joints, it was found exceedingly difficult to obtain evidence of the existence of some of the cracks by means of the penetrant inspection methods used. In the case of the smallest crack no evidence of its existence was found. Further, no indication was obtained of the existence of the crack, about 0.009 inch long, shown in figures 17 and 18 when the methods were used with this joint in the disassembled condition.

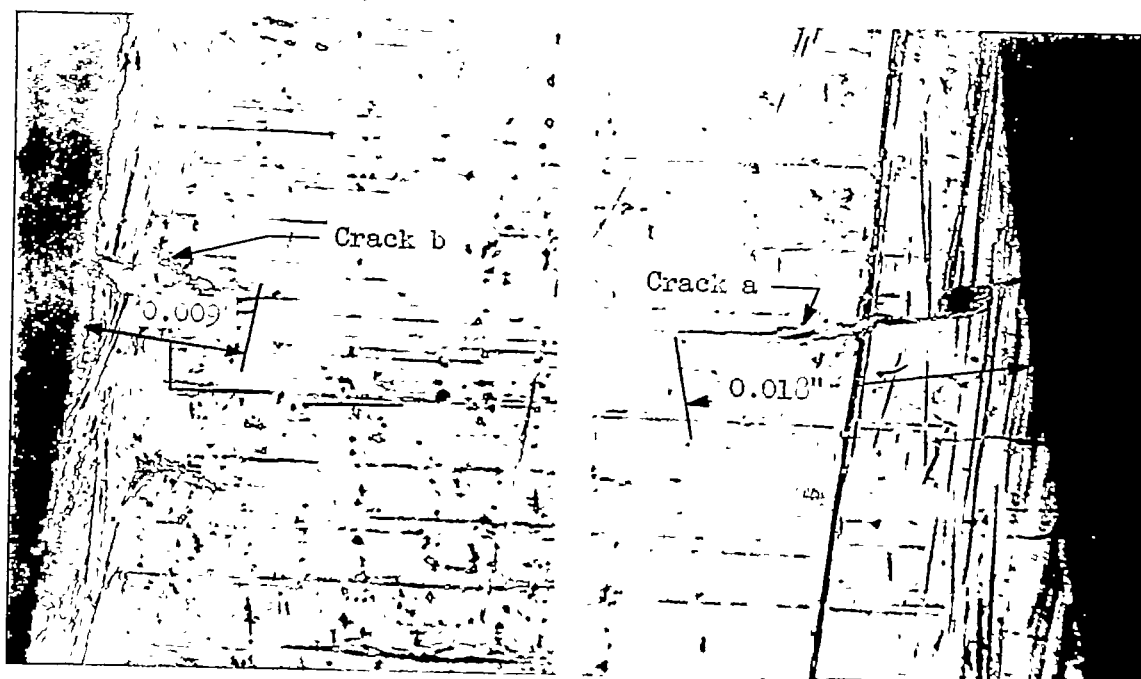
Figure 18.- Enlargements of additional failures in 24S-T4 nonuniform-step joint. (For locations, see fig. 17.) Two photographs at top are of Faxfilm replicas.

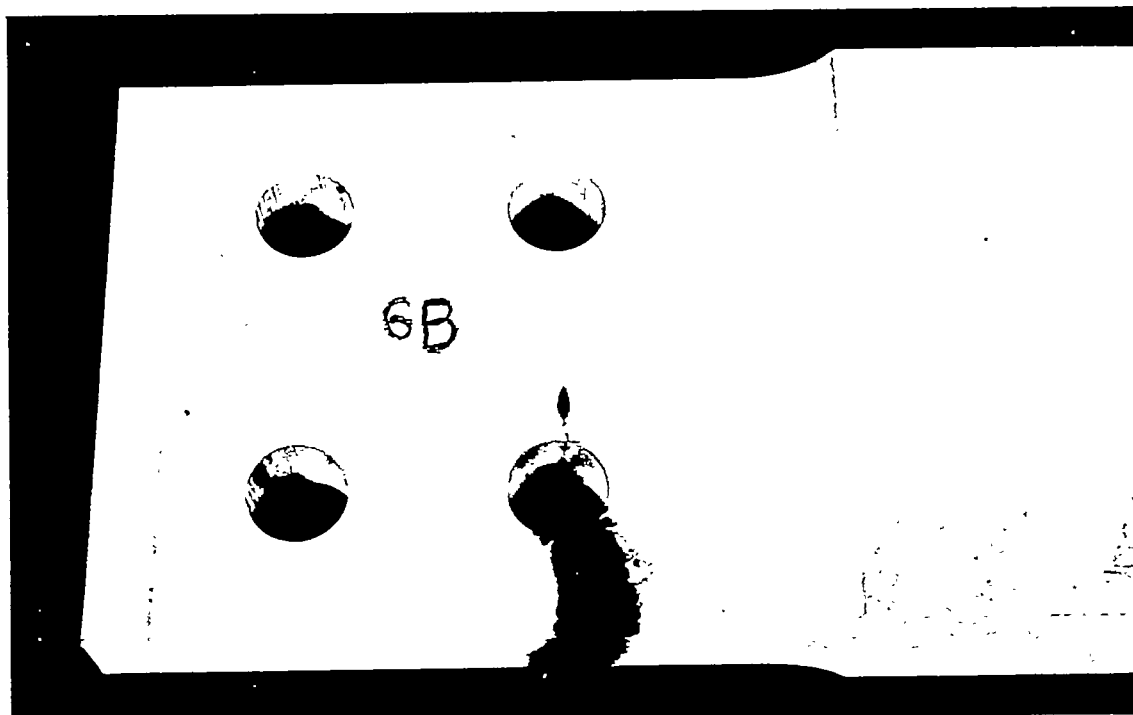
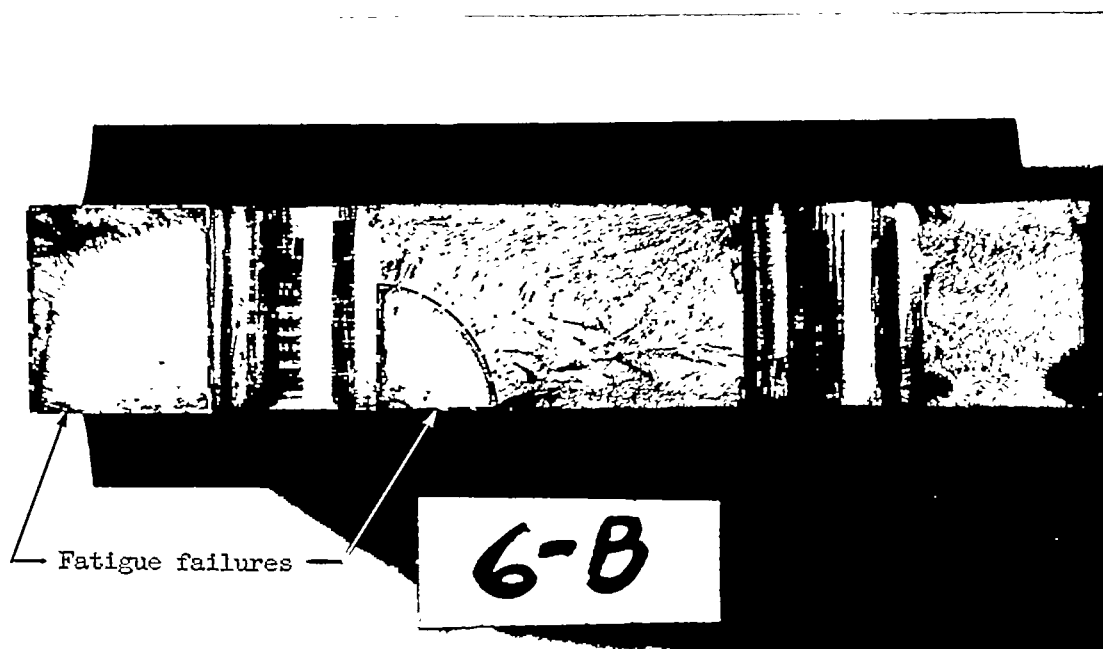
L-83699

Figure 19.- Failures in 75S-T6 double-shear joint.

The static loads required to fail the 75S-T6 and 24S-T4 double-shear joints after the fatigue cracks shown in figures 19 and 20 had been developed are given in table VII. Included in the table are comparisons with the expected load based on the net area obtained by correcting for the cracks and the load-carrying capacity of a similar joint not having previous cyclic-stress history. Outlined on the fractured surfaces in figures 19 and 20 are the areas involved in reducing the net area for estimating the effective load-carrying section of the specimens. It can be seen that one section of the 75S-T6 joint between the bolt hole and the outside edge was completely fractured by the fatigue loading whereas the 24S-T4 joint did not completely fracture in this area. Before subjecting the 24S-T4 joint to the static loading, however, a saw cut was made into the bolt hole from the outside edge in order to produce more nearly identical conditions in the two specimens. The location of the cut is shown in figure 20. Thus for purposes of the comparison this section of the joint has been considered as though it had been completely fractured in fatigue. Further, the additional failure in the centrally located portion of the joint adjacent to the bolt hole in the 75S-T6 joint caused a substantially larger reduction in the section than was the case in the 24S-T4 joint. Thus the cracked 75S-T6 joint would be expected to be subjected to a larger eccentricity of loading than the cracked 24S-T4 joint.

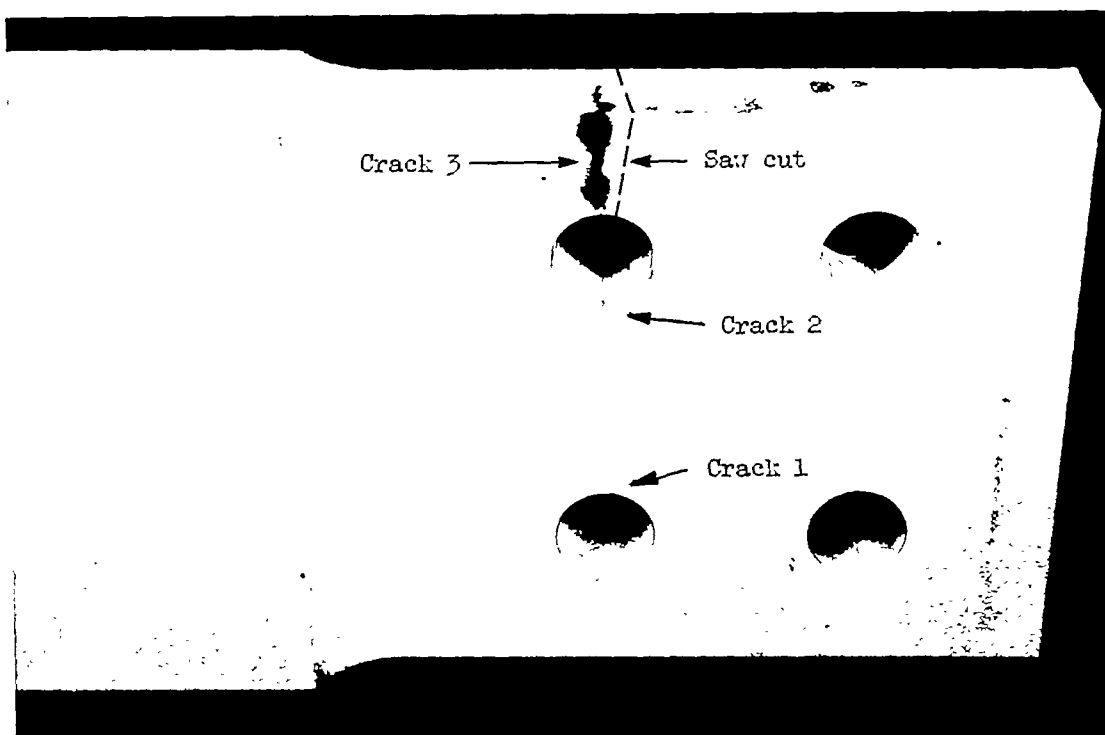
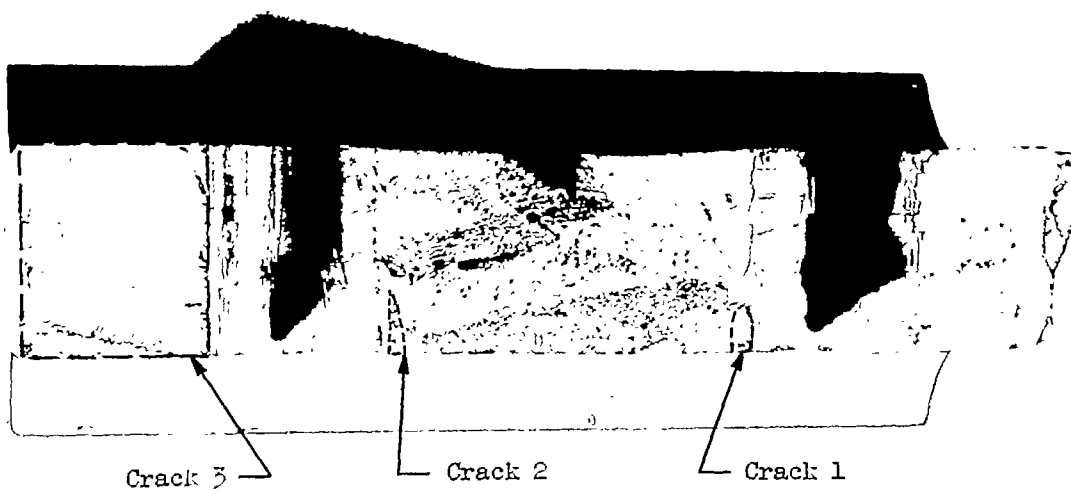
L-83700

Figure 20.- Failures in 24S-T4 double-shear joint. Specimen 6D. (For enlargement of small cracks see fig. 21.)
